An Arboricultural Report on trees growing in Public Open Spaces owned by

Marldon Parish Council,

June 2023

Date of site inspection: 7th June, 2023

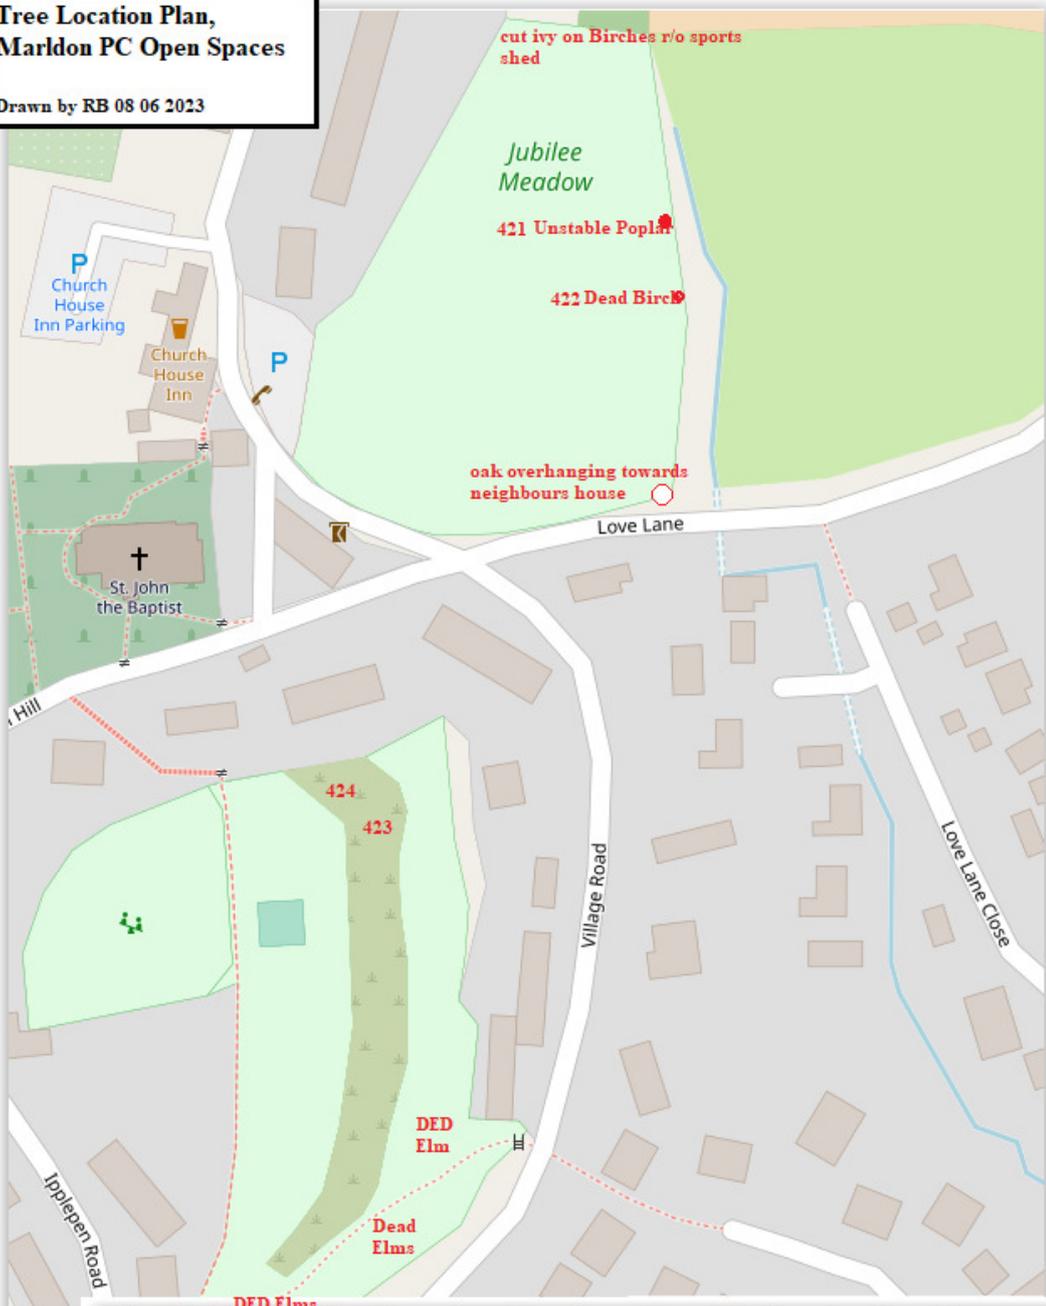
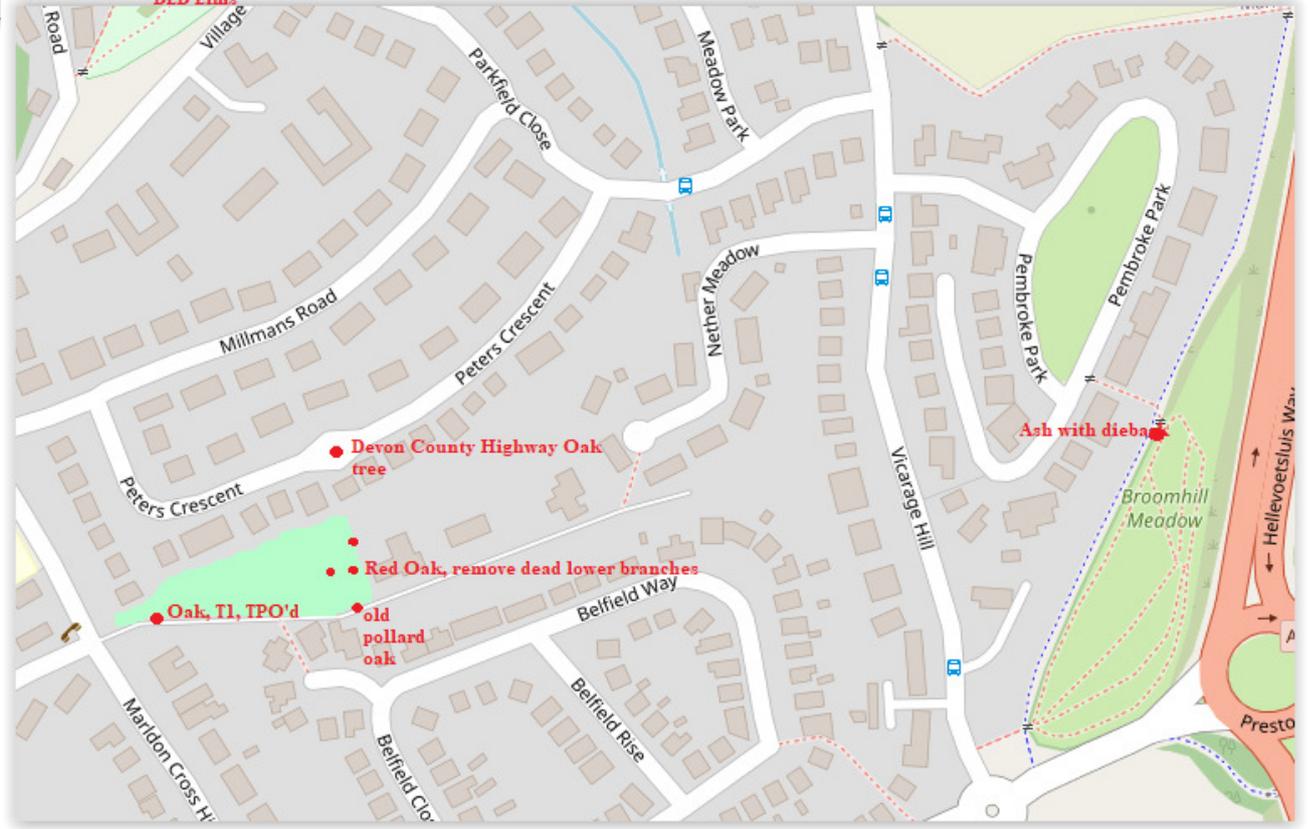
**Tree Location Plan,
Marldon PC Open Spaces**
Drawn by RB 08 06 2023

On the eastern boundary, about a third of the way down, is an early-mature hybrid Balsam Poplar; it has severe basal decay on its western side; with much deadwood in the canopy, indicating that the decay is extensive enough to interfere with water conduction from the roots. Although it is producing reaction-wood on other parts of the stem base, it is my professional opinion that it is immediately dangerous; and should be felled before the autumn storms. It is tagged 421.

Further along the eastern boundary is a dead standing two-stemmed Birch; this too should be felled; with less urgency, but it would be sensible to have the work done to both trees at the same time, as being more cost-effective. It is tagged 422

Adjacent a substation building at the southern end are a group of small dead Elm, which should be felled in due course. Other than those mentioned above, the only trees needing action are two dying Ashes, Tagged 423, 424, located at the northern end of the site. Some other ashes on site were showing signs of Chalara ash dieback disease; and should be monitored.

3.8 I have marked the various trees on the attached plan, derived from OpenStreetMap data and thus available for anyone's use.

4.6.1 Jubilee Meadow: Fell the Poplar tagged as 421, and the dead Birch tagged as 422.

4.6.2 Tor Field. Fell the various dead elms shown on plan and mentioned in 3.5.1 above; fell two dying ash trees tagged 423 and 424.
